SUBJECT: Site Inspection, H.E.Davis Construction, Henry 1 & 2, M/023/023, Juab County, Utah

Date of Inspection: May 18, 2004  
Time of Inspection: 10:00 - 11:30 a.m.  
Participants: John Childs, Kay Christofferson, Tony Christofferson - H.E. Davis; Tom Lloyd - USFS; Doug Jensen, Paul Baker, Wayne Hedberg and Tom Munson - DOGM

**Purpose of Inspection:** To inspect the mine site with their current plan which was put together by Harold E. Davis & Sons and determine what needs to be done to update the bond and plan.

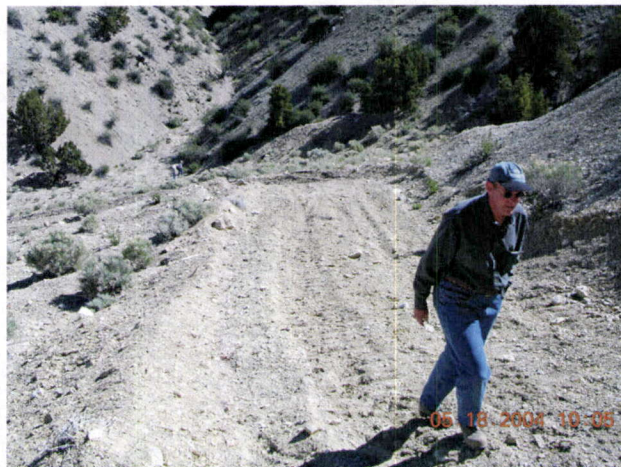
DSCN1593.JPG 2004/05/18 10:05:34

PAUL WALKING ROAD

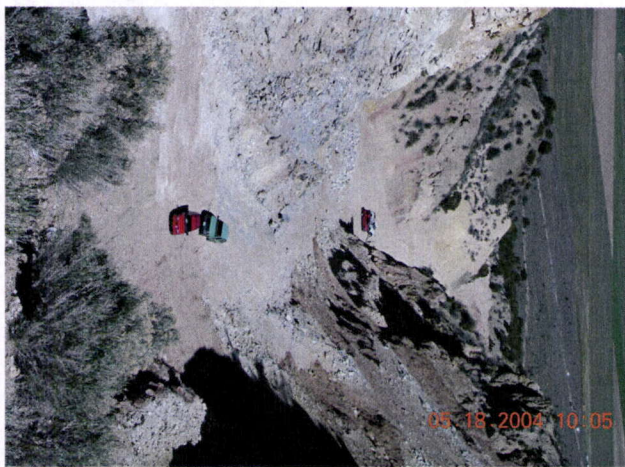
DSCN1594.JPG 2004/05/18 10:05:50

LOOKING WEST

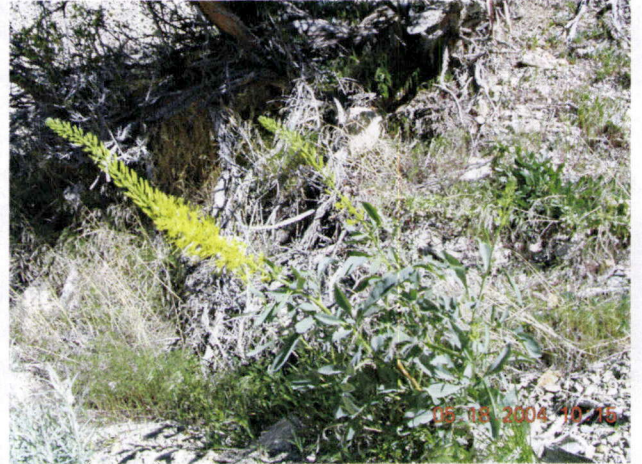
DSCN1609.JPG 2004/05/18 10:15:35 PRINCESS PLUME

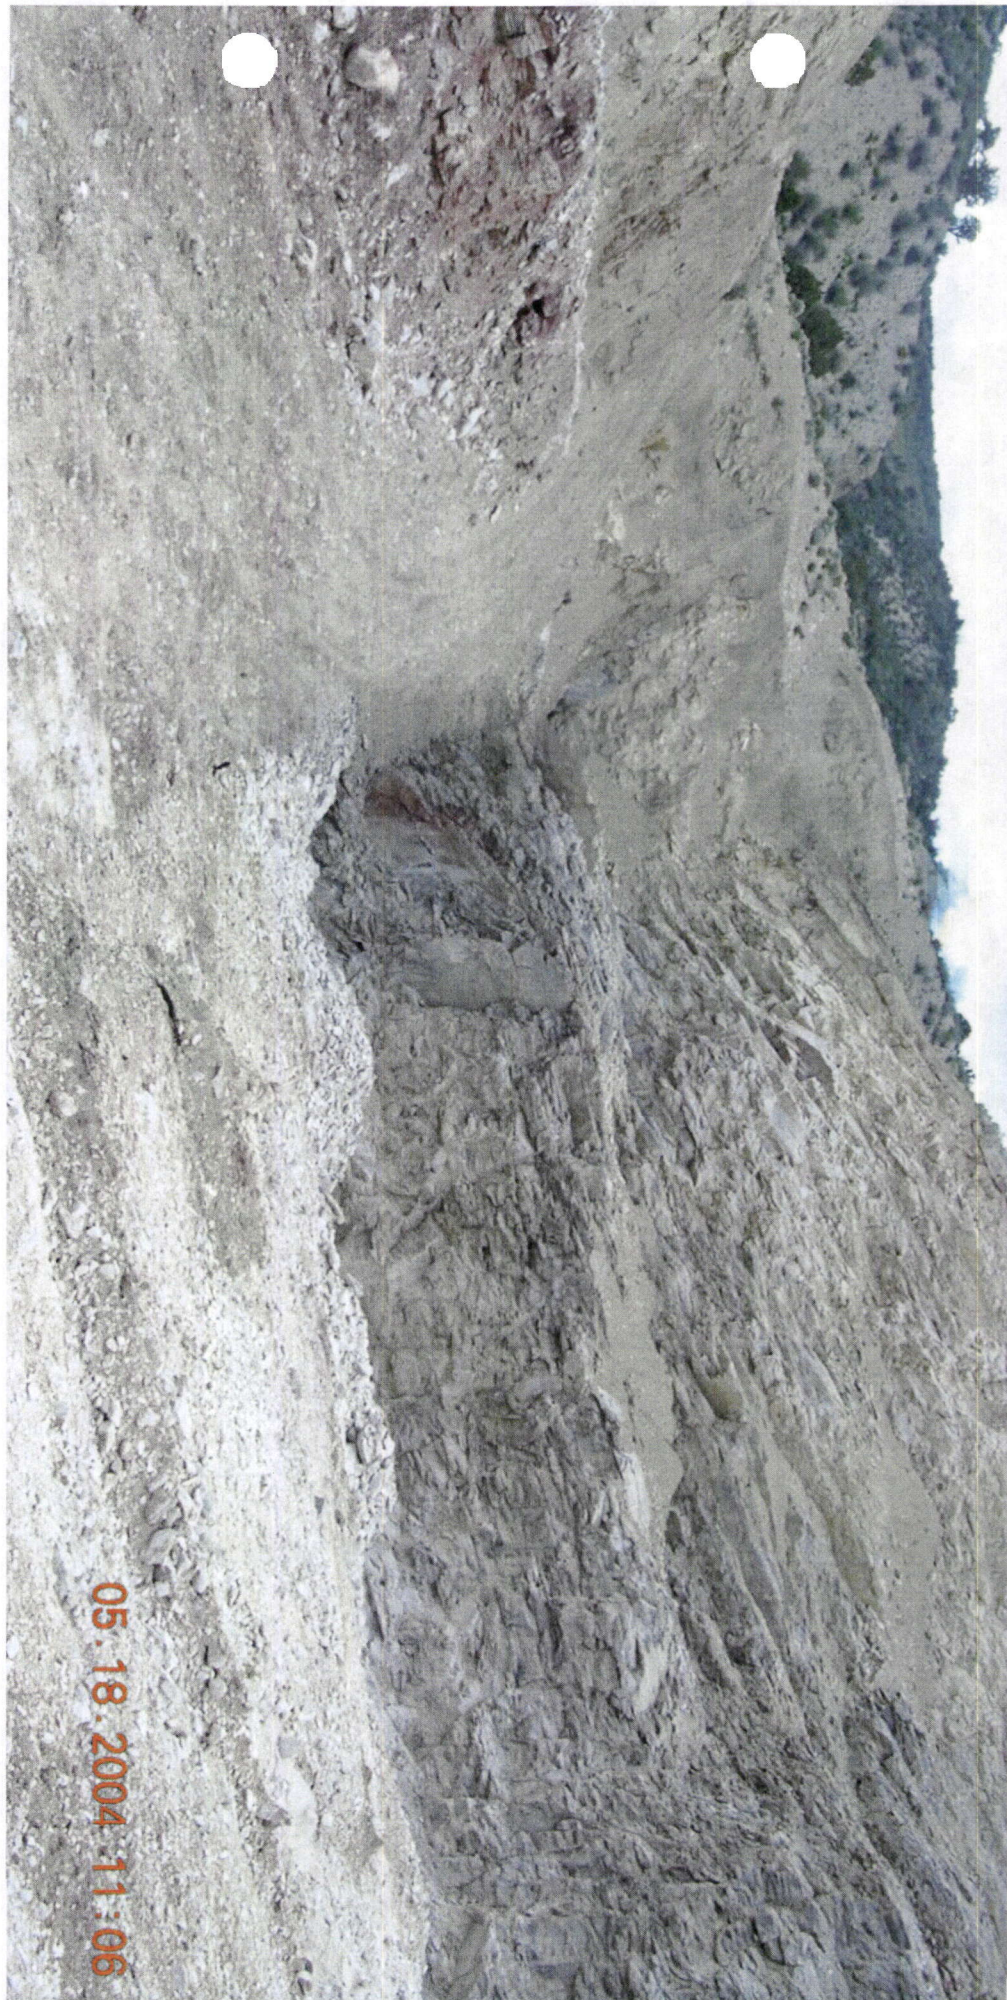
HIGH WALL - EASTERN END  
OF D.I.T

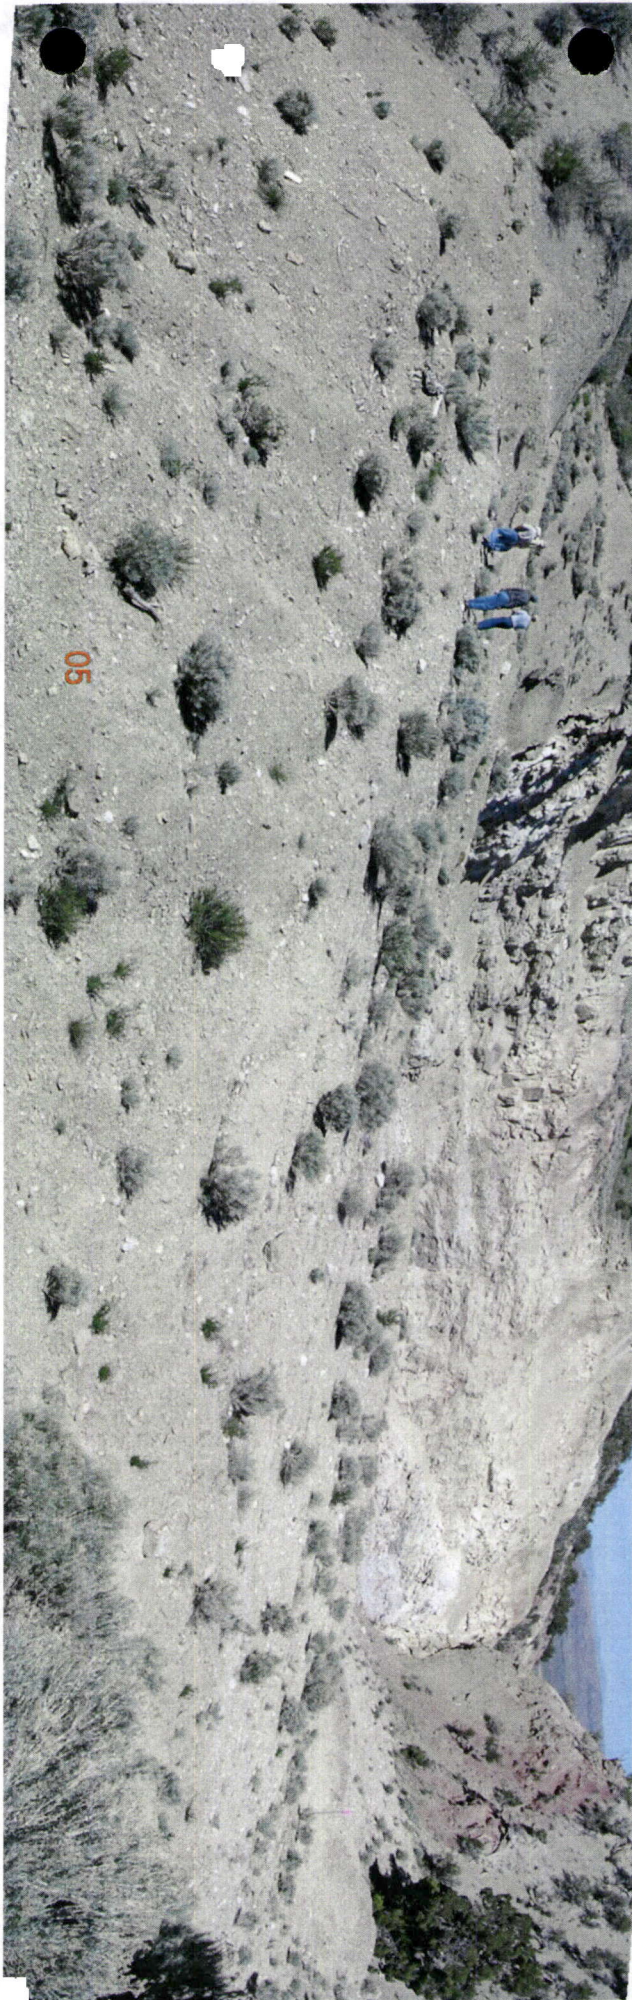
EASTERN MOST RECLAMED  
AREA.

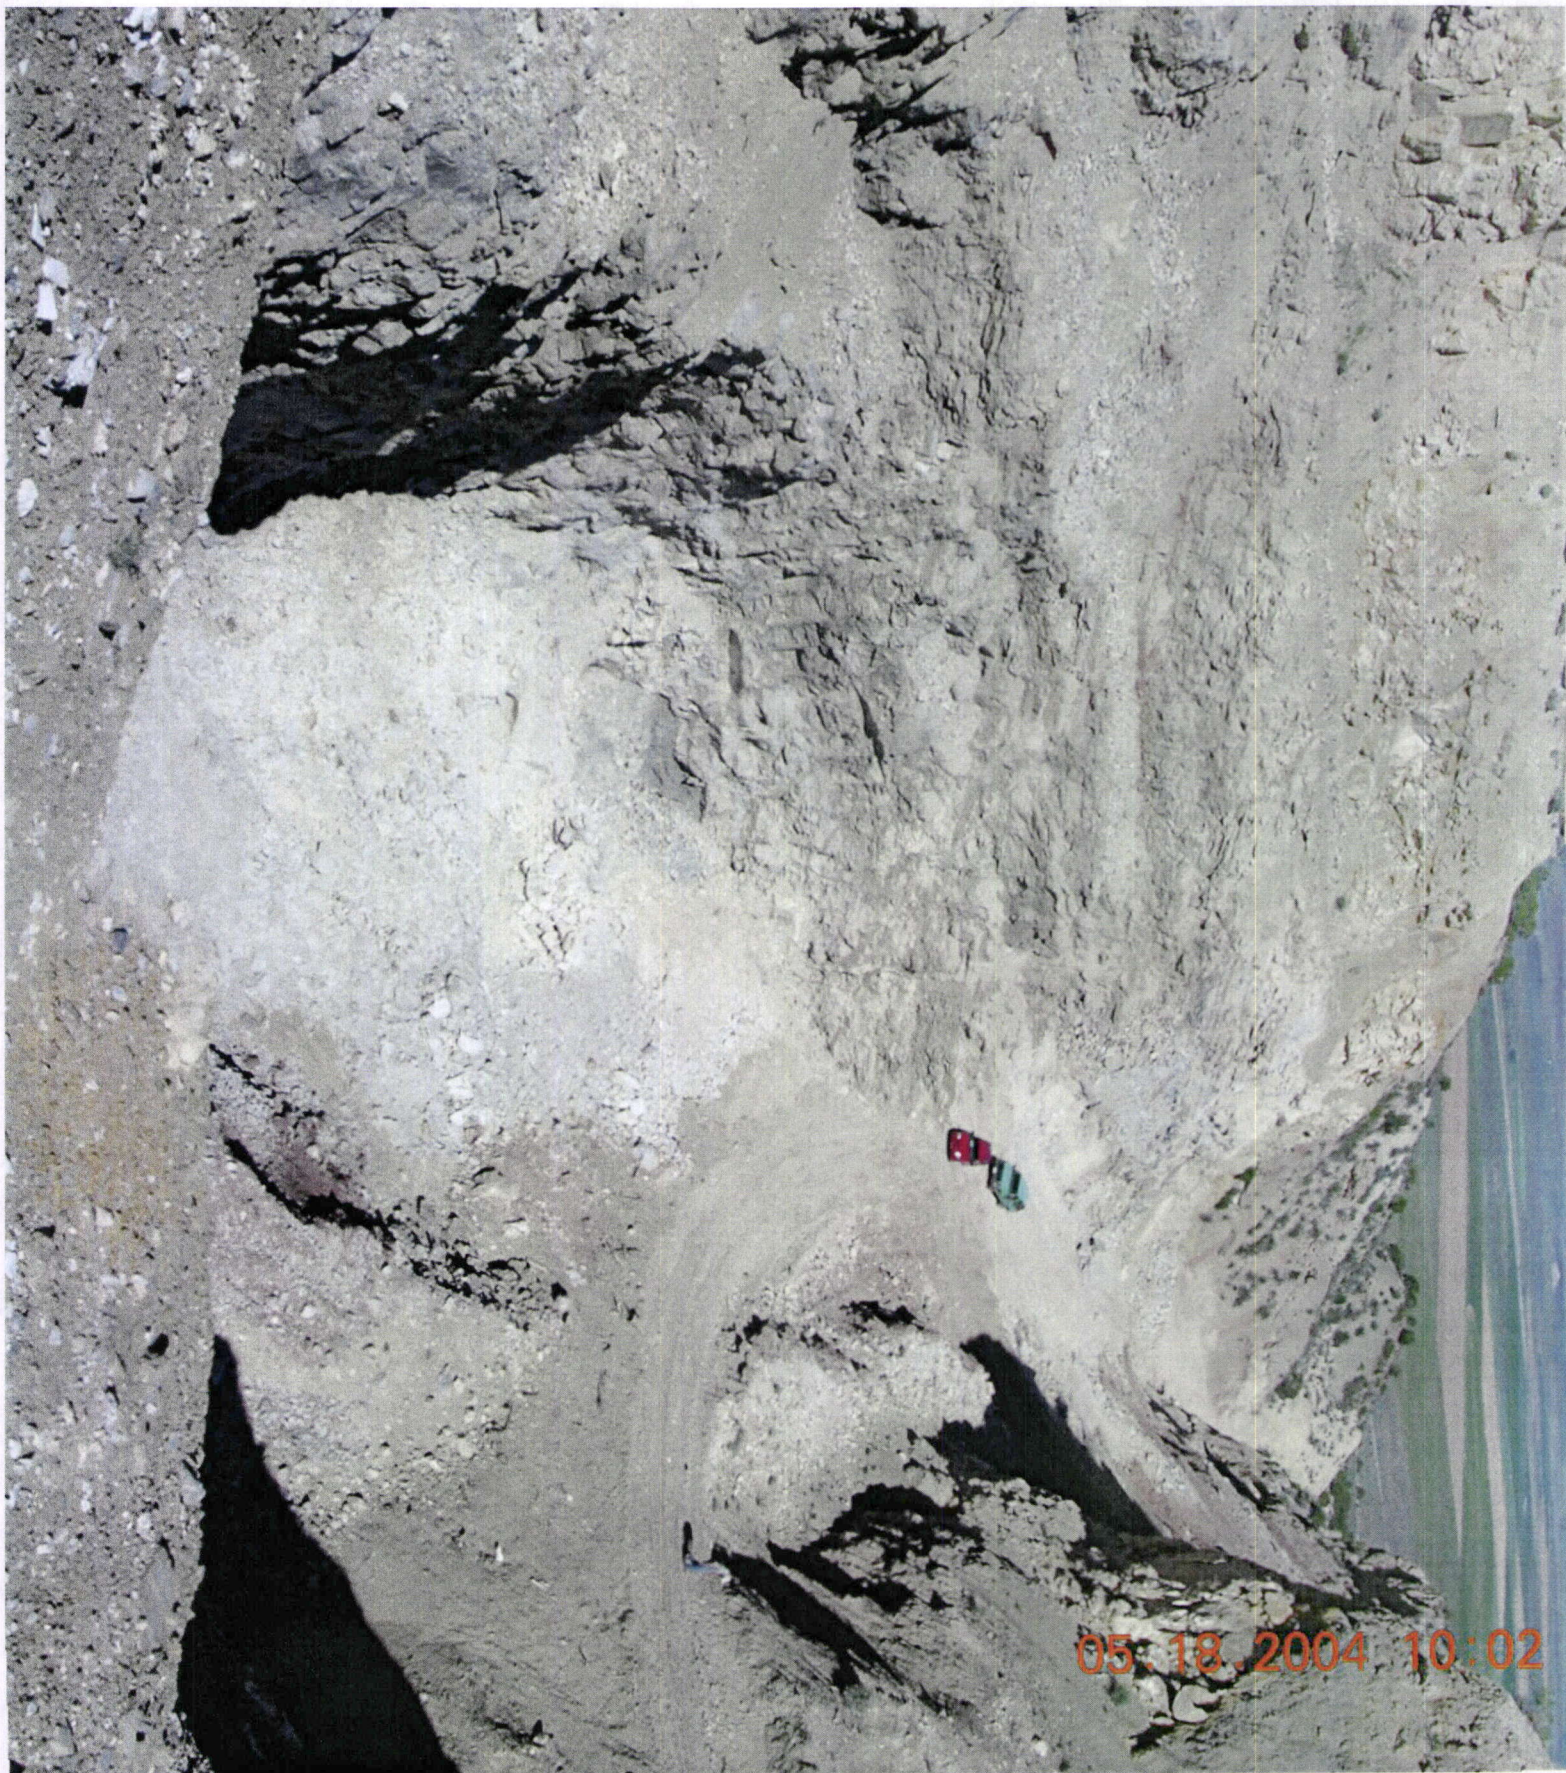
PIT AND HIGHWAY

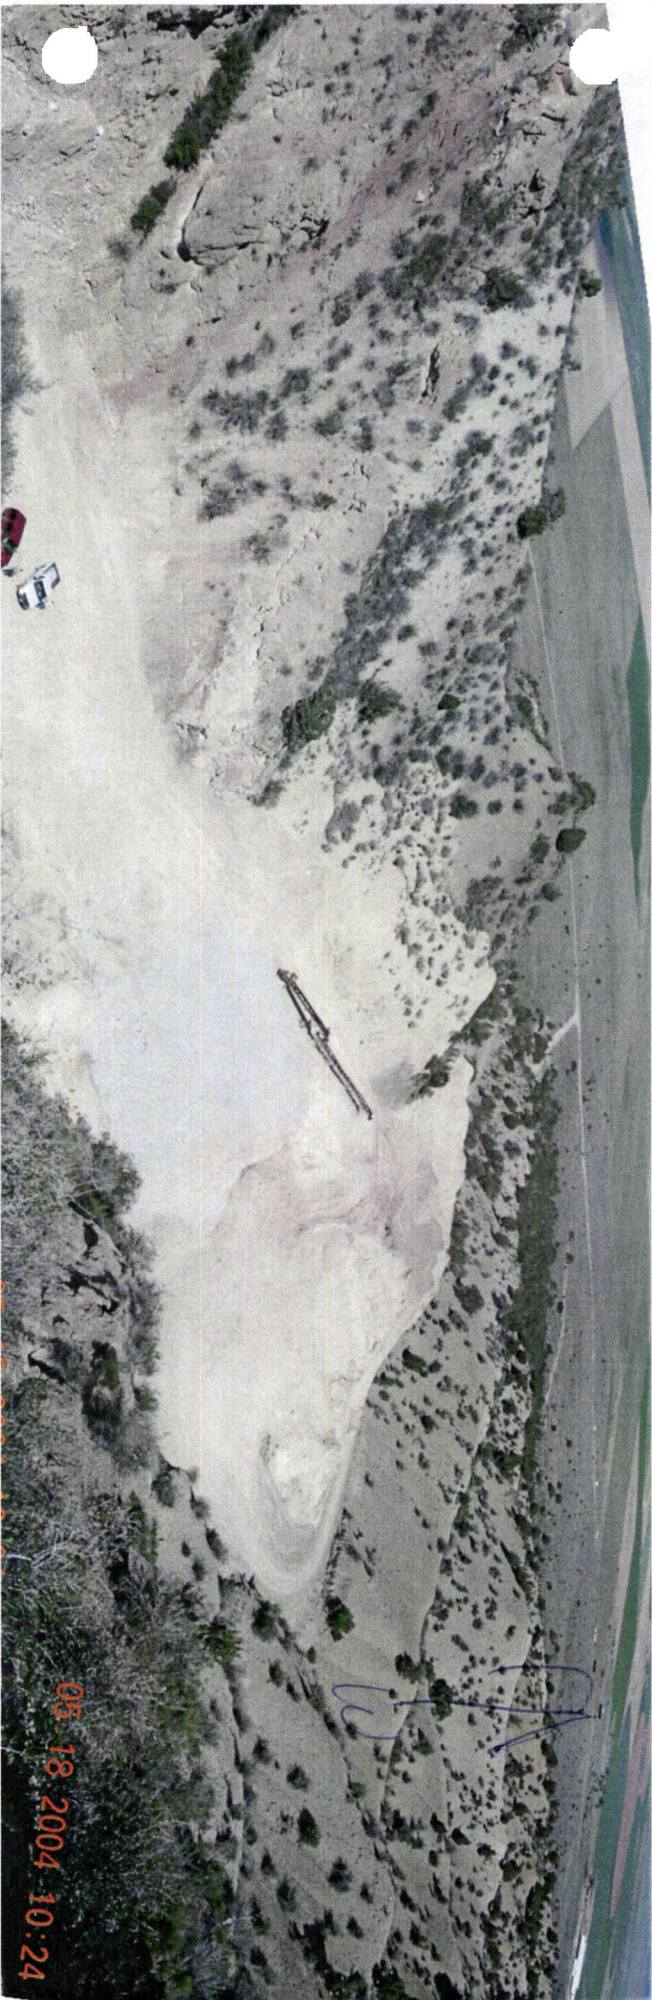
STOCKPILES AND  
DEBRIS  
KOOHIL WEST

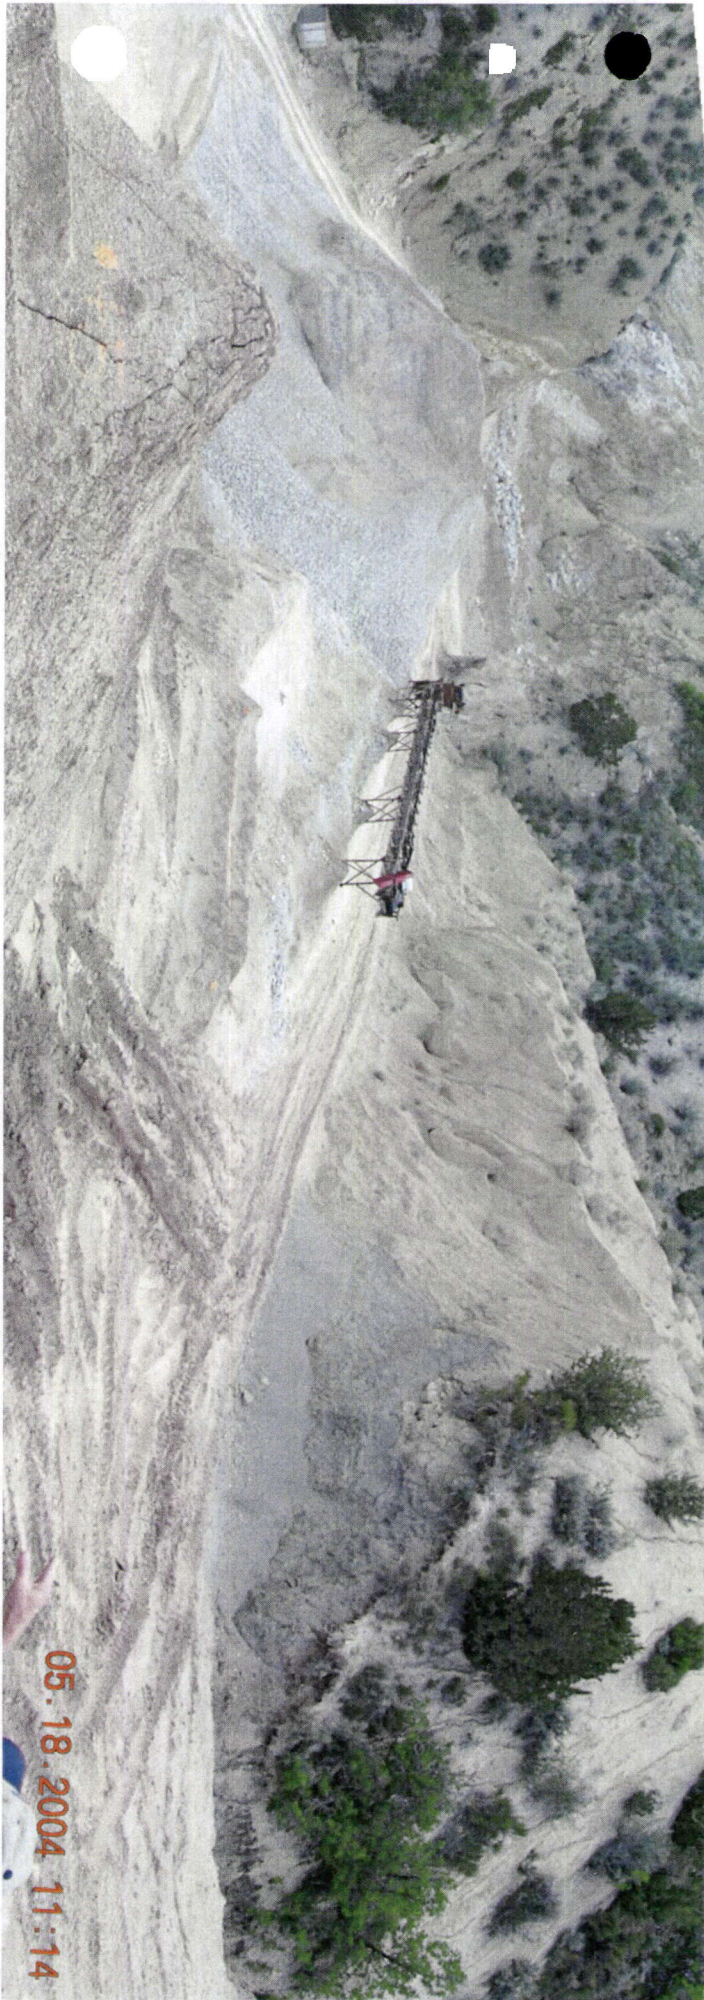
STOCK PILES AND LEFT OVER  
CRUSHER SPIN

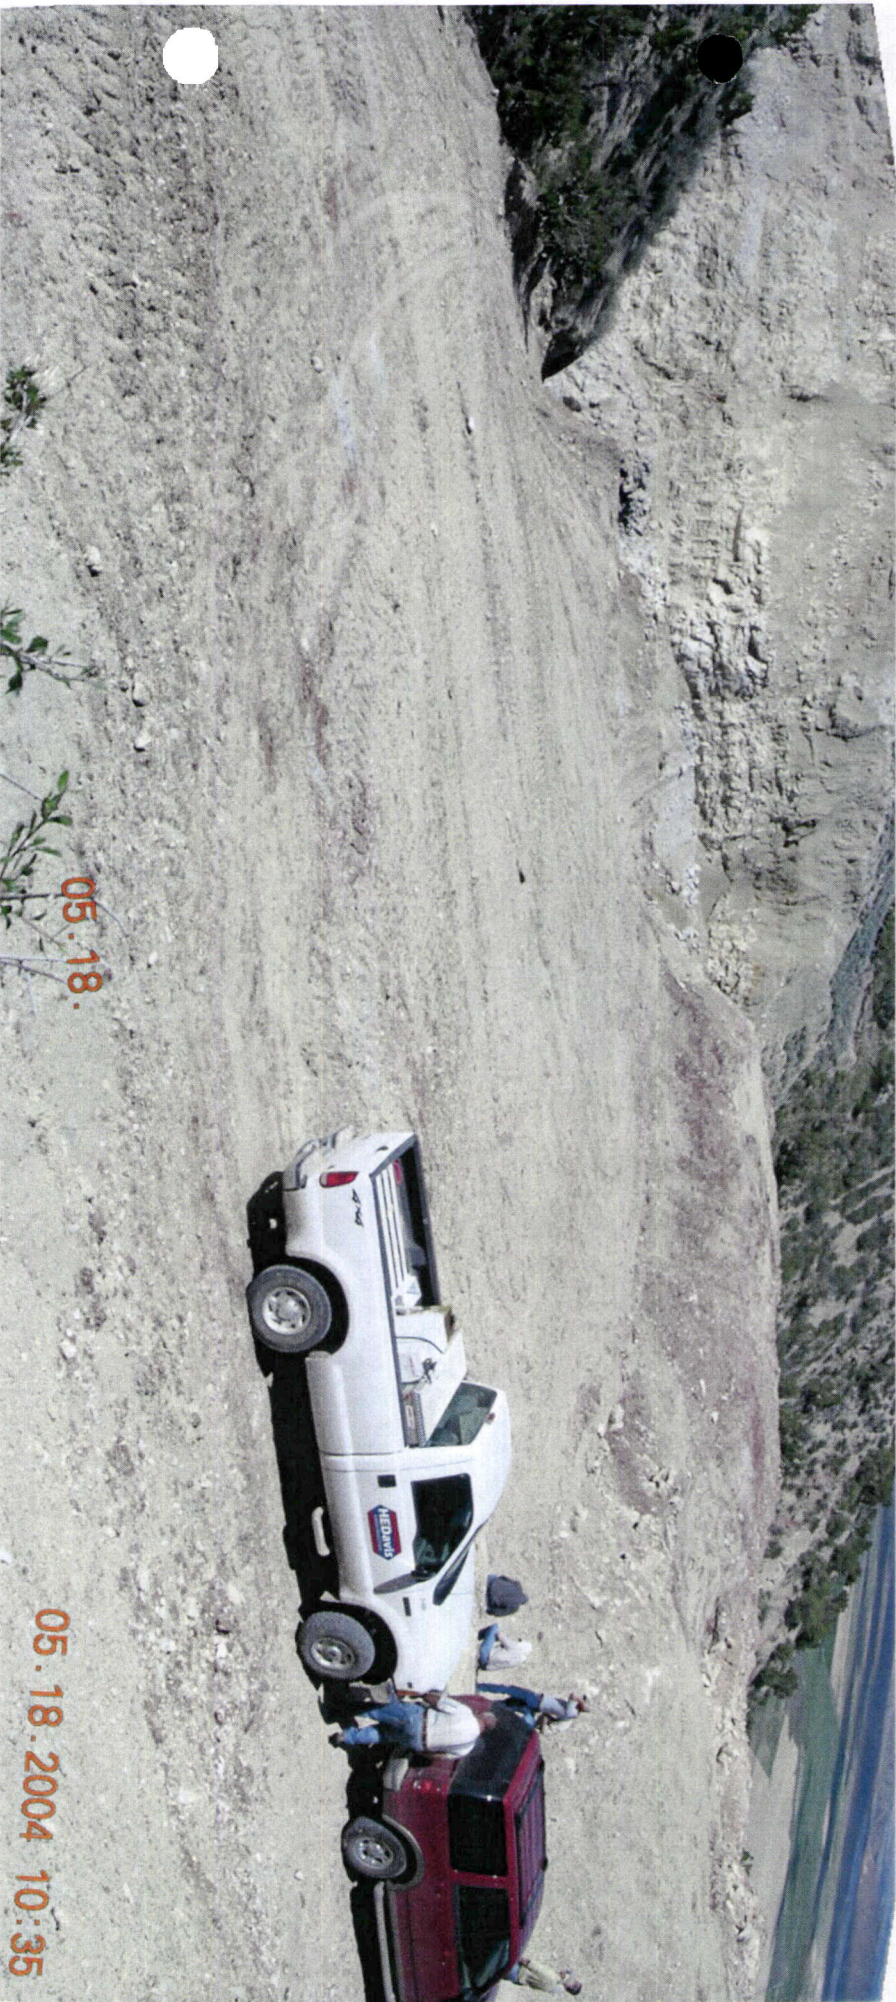
REGARDED WAITING FOR  
SUCCESSFUL REGISTRATION

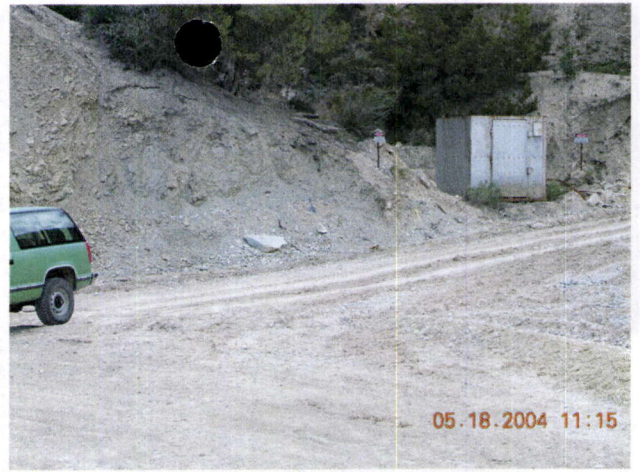
DSCN1639.JPG 2004/05/18 11:15:43

*DYNAMITE BOX*

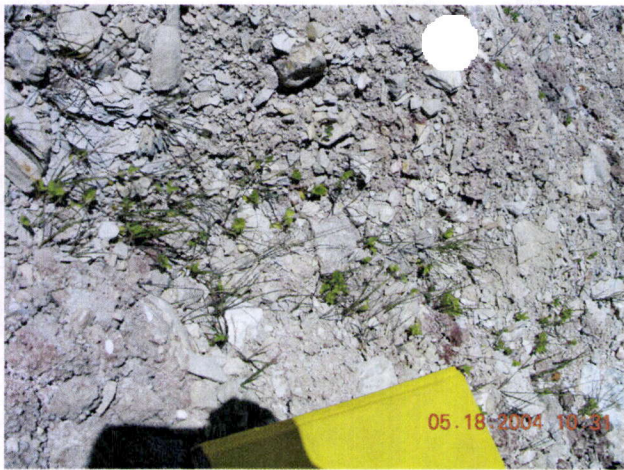
DSCN1622.JPG 2004/05/18 10:31:09

RECLAIMED AND  
STEEPED FALL 2003

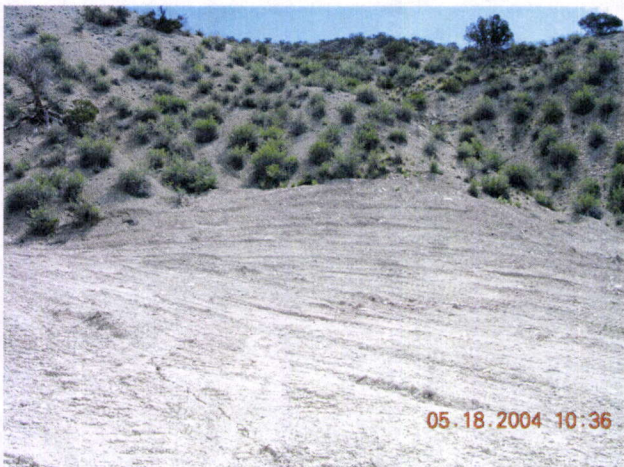
DSCN1626.JPG 2004/05/18 10:36:48

WEST END  
ROAD LEADING TO  
RECLAIMED AREA

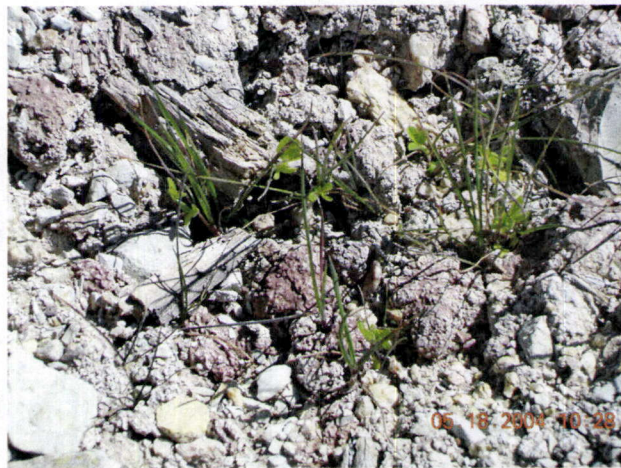
DSCN1621.JPG 2004/05/18 10:28:49

LOWER PAD  
← NEW GROWTH - REGRADED  
6' 4 SEEPED AREA 16
